WOLF CREEK DAM

NDS ID NO. PA-00664

PHASE I INSPECTION REPORT
NATIONAL DAM INSPECTION PROGRAM

AUGUST 1978

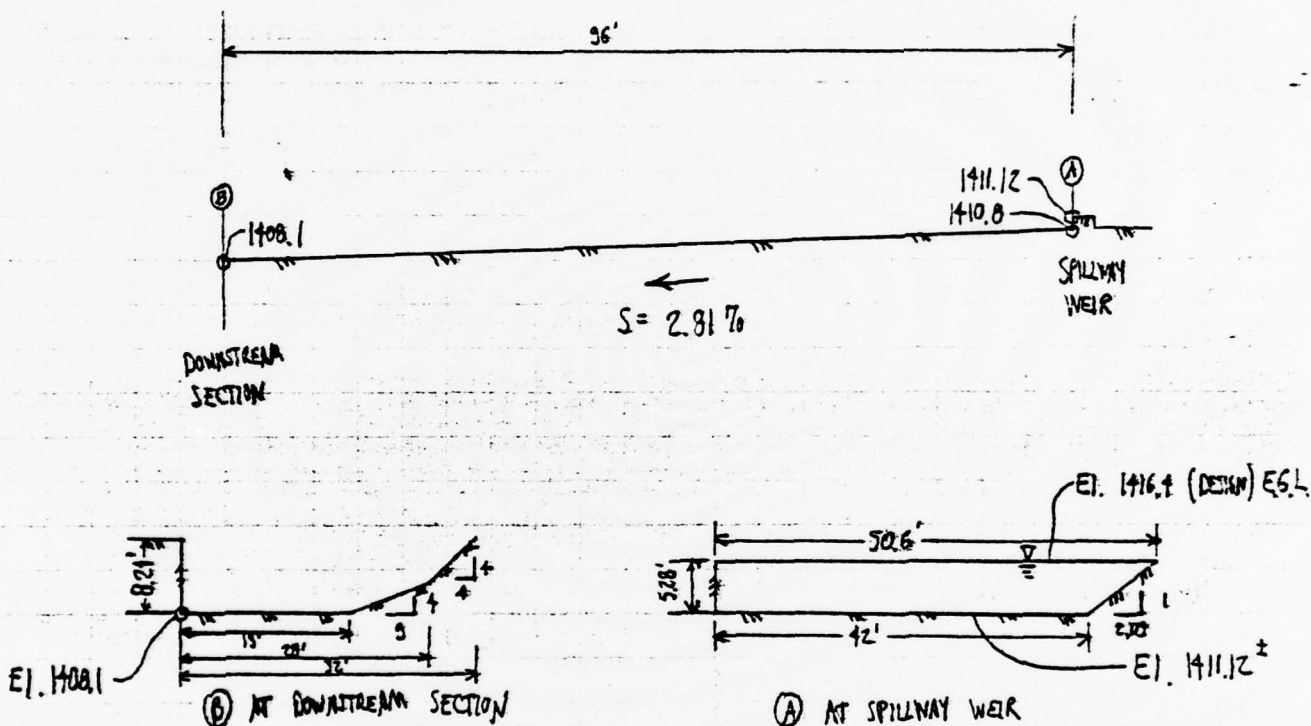
DURING THE VISUAL INSPECTION OF WOLF CREEK DAM, IT WAS NOTED THAT THE HYDRAULIC CONTROL SECTION OF THE SPILLWAY CHANNEL MAY SHIFT FROM THE WEIR TO A SECTION DOWNSTREAM APPROXIMATELY WHERE THE SPILLWAY OUTLET CHANNEL SLOPE INCREASES TO ABOUT 1H ON 1V. CHECK ENERGY REQUIRED AT THE DOWNSTREAM SECTION TO PASS THE DESIGN CONDITION DISCHARGE WITH THE RESERVOIR WATER SURFACE ELEVATION TO DETERMINE IF AN OBVIOUS SUBMERGENCE OF THE SPILLWAY WEIR EXISTS.

DEPTH OF FLOW AT (A), DESIGN Q = 1,440 CFS
